# RAINBOW FOOT OVER BRIDGE COLLAPSE AT JNS (2010)

## **1. Synopsis:-**

This article is about the Foot Over Bridge, the deck of which collapsed on 21<sup>st</sup> September 2010, while laying concrete of the deck slab.

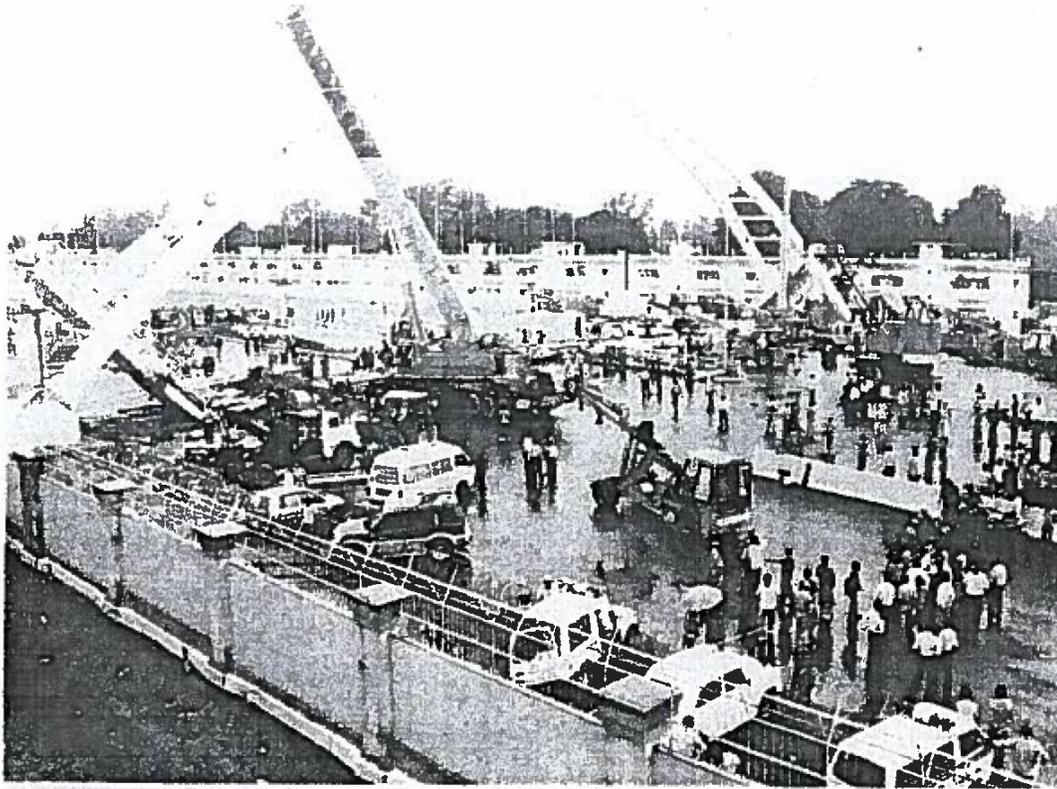
The contractor submitted the fabrication and erection methodology of the paired arches and erected the arches successfully on piled foundations as shown in SKETCH No. 1. The suspenders were installed as per the instruction manual of Mac-alloy, being bought out items. The contractor, accordingly installed the suspenders as per approved drawings to hang the steel pre-fabricated deck structure for both the FOBs. However when the concreting of the one FOB was being laid and about 45 m of deck length was poured the deck fell down with a thunderous sound injuring 27 workers, some seriously, breaking itself in three parts, though no life was lost (Photo No.2).

**Photo no. 2:- Showing Collapsed deck of FOB**

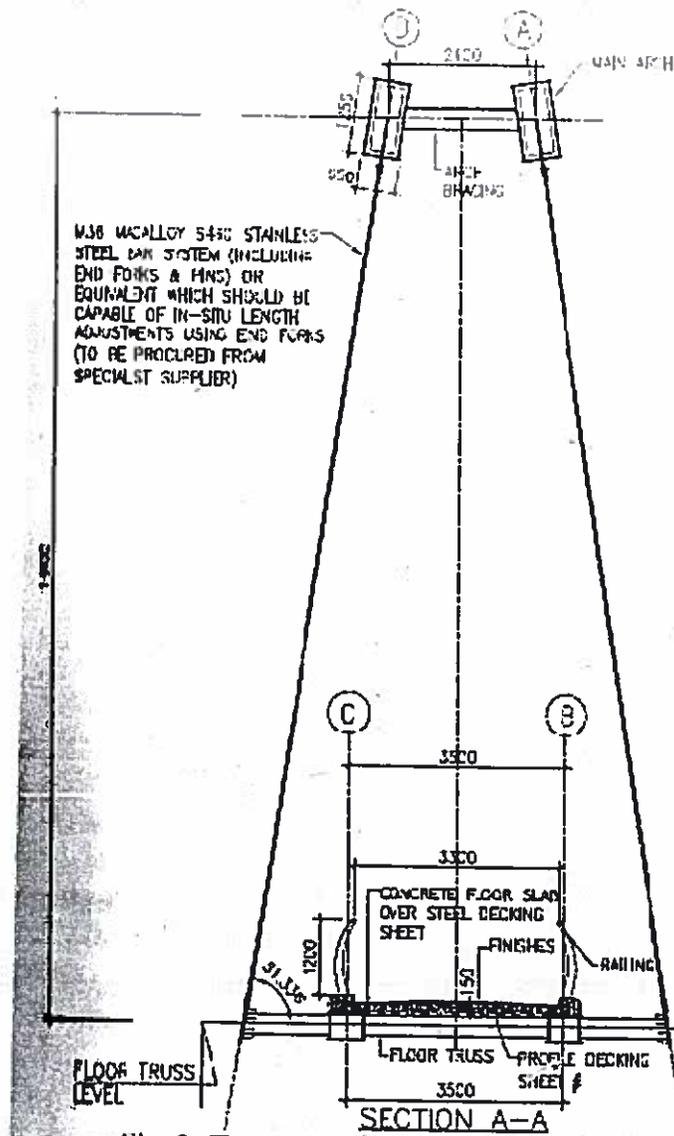
SKETCH No. 2: Transverse Sectional Elevation at Crown of Arch

The remarkable design of FOB was conceived by M/s TCPL and approved by Delhi PWD. TCPL proposed paired-arches of fabricated steel box section of size 1250 mm x 650 mm, span 80m, rise 14.6 m, braced with pipes of 350 mm dia, splayed at supports by 8.80m from 3.40m at the crown. The deck of span 80 m, width 3.50 m was having fabricated steel boxes of max. size 550 mm x 550 mm at c/c distance of 3.5m braced by square box sections to supports a 150 mm thick RCC deck slab. The deck was proposed to be hung by twenty six Macalloy S -460 stainless steel suspenders of diameter 36 mm at 5 m c/c. The maximum length of suspender being 14.6 m and maximum inclination from vertical of 9 degrees. The suspenders were tied at bottom centre of the arches at top and to a cantilevered plate connection on both sides at deck level, SKETCH No. 2.

The deck has been connected to hangers through a cantilever bracket which has been attached with a plate at the end, which is not a robust connection, the transverse beam/ cross girder should be a single beam & longitudinal beams/ stringers provided in between, which will be a dependable arrangement, SKETCH No. 2.

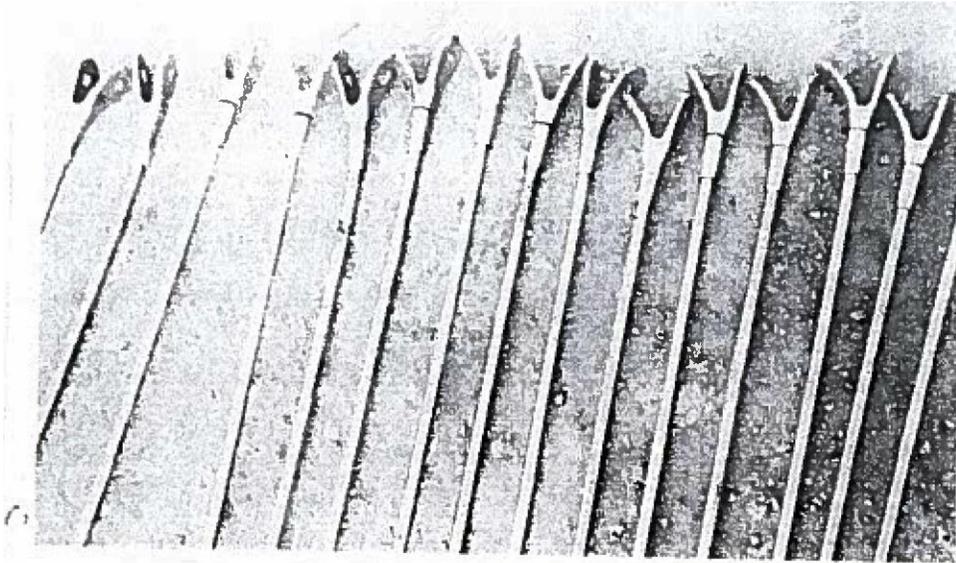
1. It is obvious that the suspension fork and pin have given way because the pin has been detailed by the designer perpendicular to the axis of the bridge which restricted the movement of the suspender around the pin to cater to the changing deflection caused by the loading. The eye lets of the fork opened out due to inadequate fastening/ locking of the pin because of uncatered load/ moment as shown in photos no. 3 (a), (b) & (c).

**Photo no. 3(c): Bending of the arm of the fork type connector was seen in almost all the suspender rods retrieved from the site.**

The post collapse evidence was reviewed. It was concluded that a progressive collapse occurred due to the failure of “Architectural” components in the fork-type connectors at the ends of suspenders Photo – 3. This progressive collapse of the bridge was aided by the heavy RCC deck slab (Deficiency 9), and the larger suspender spacing chosen by its designers (Deficiency 1).

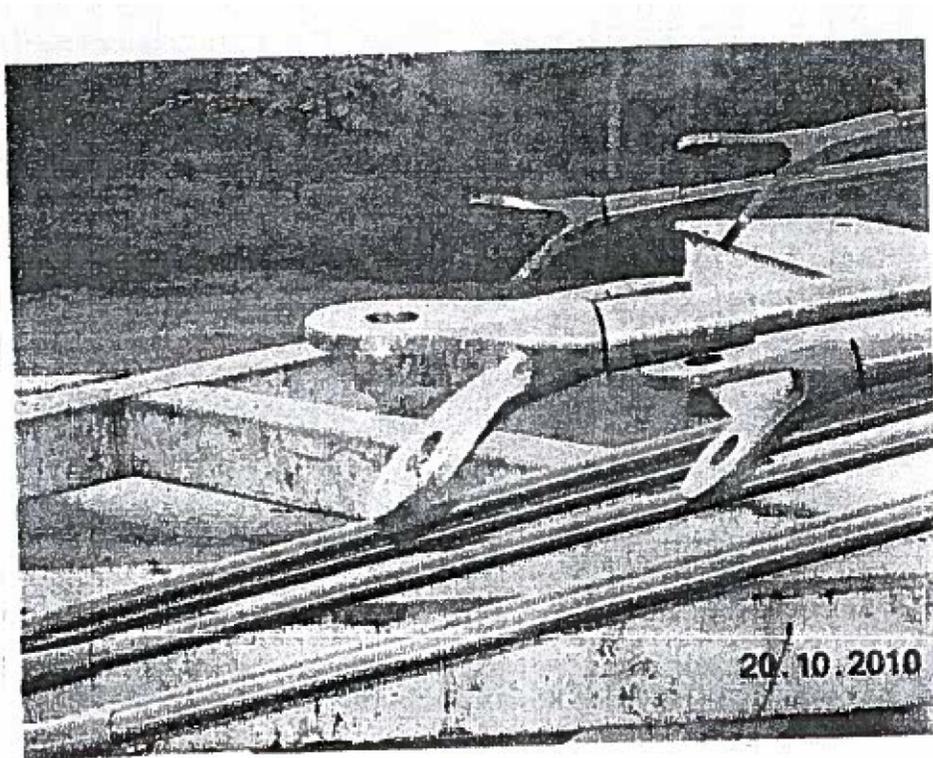
**Photo No. 4: Close up view of a fork-type connector retrieved from the collapsed bridge.**

caused failure/ bending of the fork arm, hence the pin and thus the bridge. It is clear from the failure pattern of different hangers shown in photo 3 & 4.

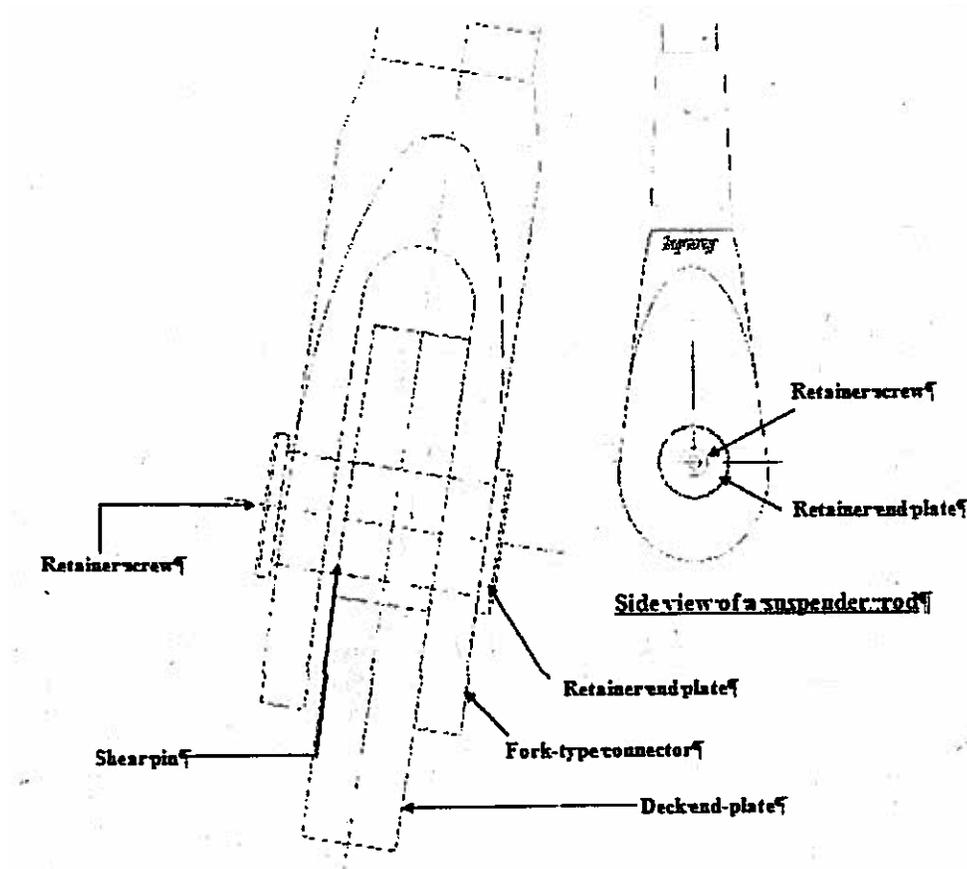
**SKETCH NO. 3: Typical arrangement of a fork-type connector and names of its parts.**

The incorrect fork arrangement provided with the pin in the transverse direction of the deck (T-T axis) has restricted the transverse rotation of the deck, while the pin should be provided in the longitudinal direction, SKETCH No. 3 & 4. It has lead to loading of the fork arm for which the product is not designed for. It has

The undisputable cause of collapse, as indicated in the various Enquiry Reports, and studied by the authors, is tensile failure of the Retainer Screw of M -6 (Nominal rod diameter 4.5 mm) due to Bending moment caused in the Fork legs due to inclination of 9 degrees of the suspender and incorrect orientation of the Fork/ pin as shown in SKETCH – 4).

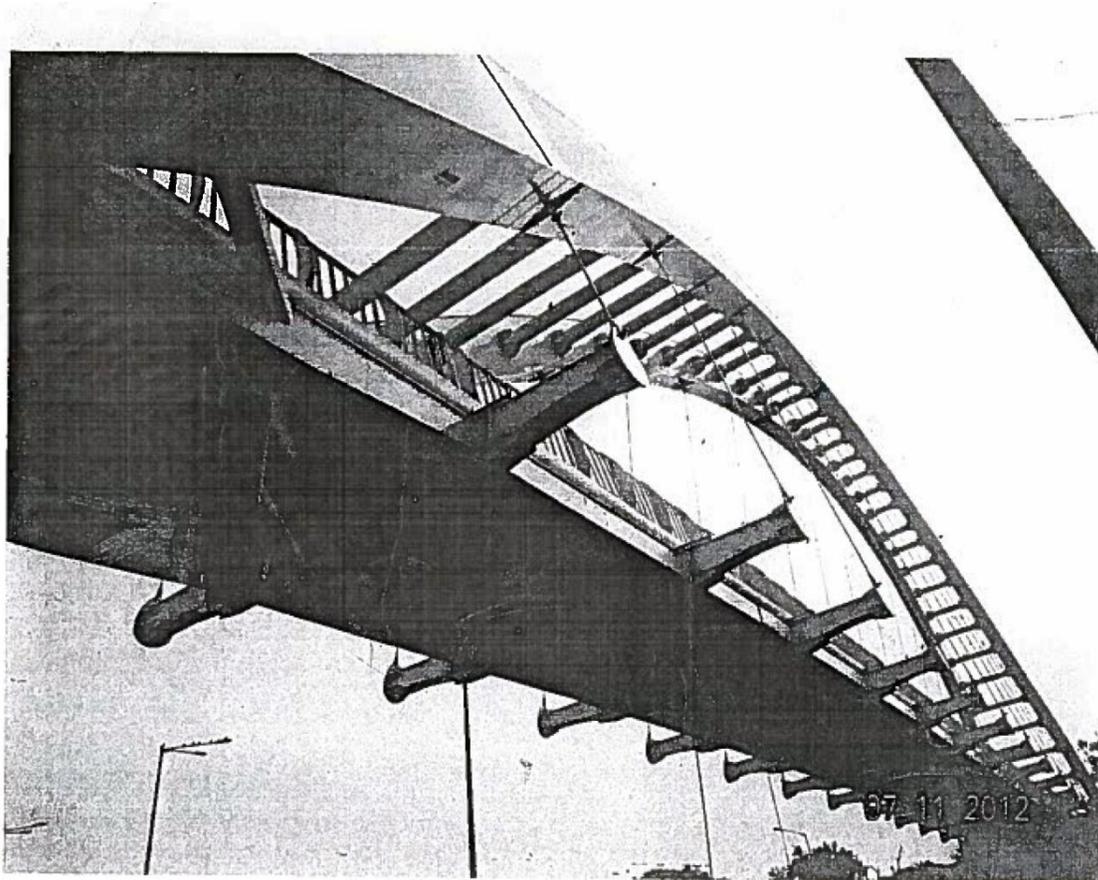
**Photo No. 6: Showing the view of Completed modified suspender bolted connections**

The re-construction of the FOBs was resumed after replacement of 36 mm dia Macalloy SS suspenders with high strength steel wire ropes of 80 dia, modification of pin connection to bolted connections, (Photo No. 5), provision of bearings at supports all proposed by the contractor. The completed FOBs were load tested by the contractor before acceptance by the Owner. Both the Foot Over Bridges are in use since February 2013 and have won “AWARD OF EXCELLENCE” (Photo No. 7).
