# RAINBOW FOOT OVER BRIDGE COLLAPSE AT JNS (2010)

## **1. Synopsis:-**

This article is about the Foot Over Bridge, the deck of which collapsed on 21<sup>st</sup> September 2010, while laying concrete of the deck slab.

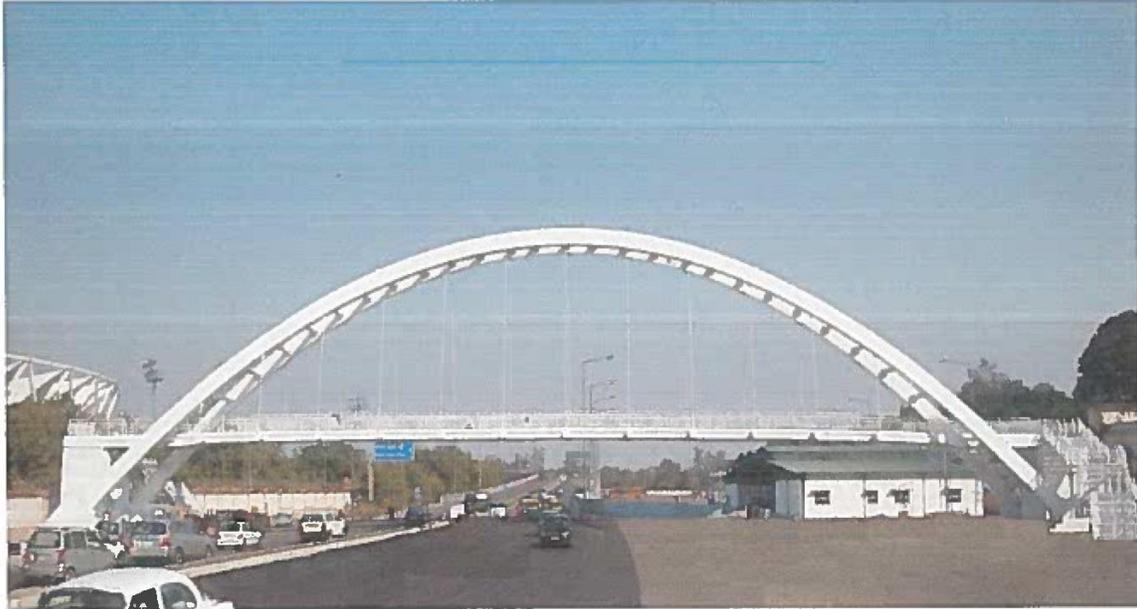
**Photo no. 1:- Showing completed Structure of FOB.**

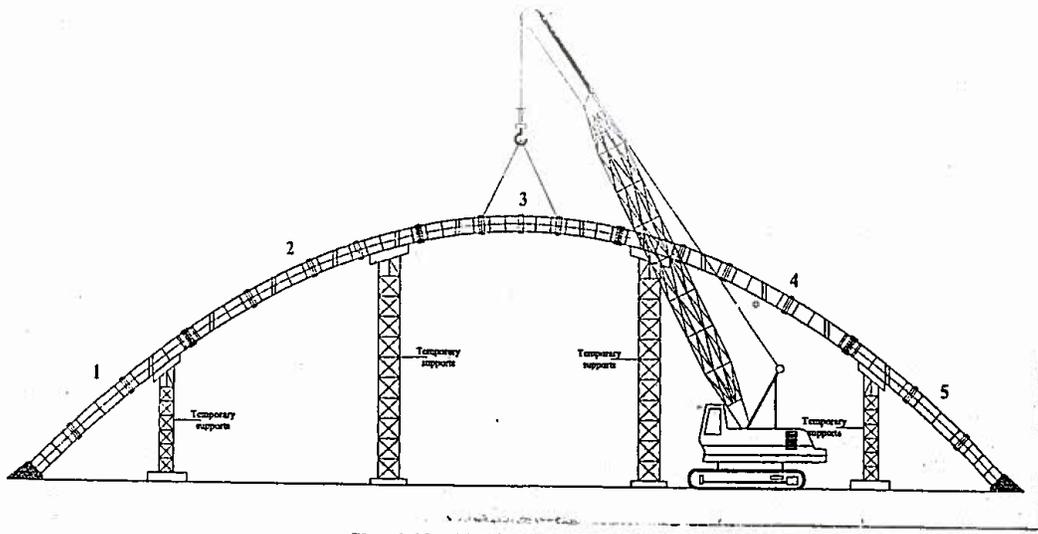
Sketch No. 1(a) Showing Erection Methodology

The contractor submitted the fabrication and erection methodology of the paired arches and erected the arches successfully on piled foundations as shown in SKETCH No. 1. The suspenders were installed as per the instruction manual of Mac-alloy, being bought out items. The contractor, accordingly installed the suspenders as per approved drawings to hang the steel pre-fabricated deck structure for both the FOBs. However when the concreting of the one FOB was being laid and about 45 m of deck length was poured the deck fell down with a thunderous sound injuring 27 workers, some seriously, breaking itself in three parts, though no life was lost (Photo No.2).

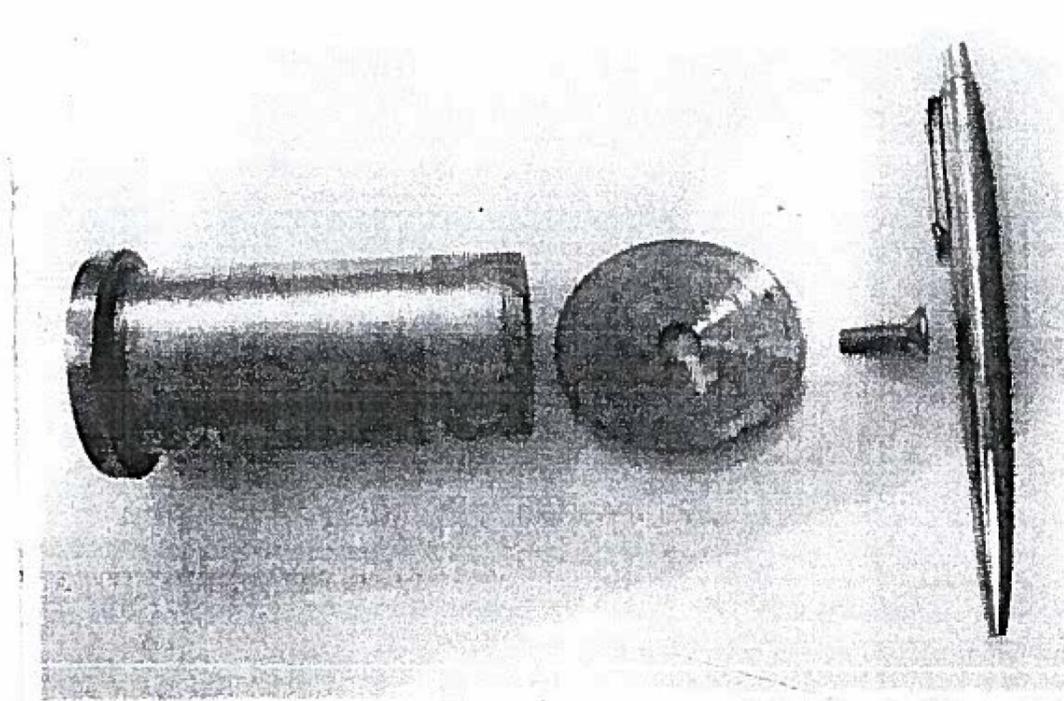
**Photo No. 5: Exploded view (L–R) of a shear pin with an end-retainer plate attached at its left end, end retainer plate and a retainer screw. A pen is placed next to these components for purpose of comparison with respect to sizes of the different components.**

The re-construction of the FOBs was resumed after replacement of 36 mm dia Macalloy SS suspenders with high strength steel wire ropes of 80 dia, modification of pin connection to bolted connections, (Photo No. 5), provision of bearings at supports all proposed by the contractor. The completed FOBs were load tested by the contractor before acceptance by the Owner. Both the Foot Over Bridges are in use since February 2013 and have won “AWARD OF EXCELLENCE” (Photo No. 7).
